Leading Edge Blade erosion (LEE) and the biproducts – Microplastics and Bisphenol A

Leading Edge erosion and pollution from wind turbine blades

5 th. Edition - English

Asbjørn Solberg, Bård-Einar Rimereit and
Jan Erik Weinbach
“THE TURBINE GROUP” JULY 2021

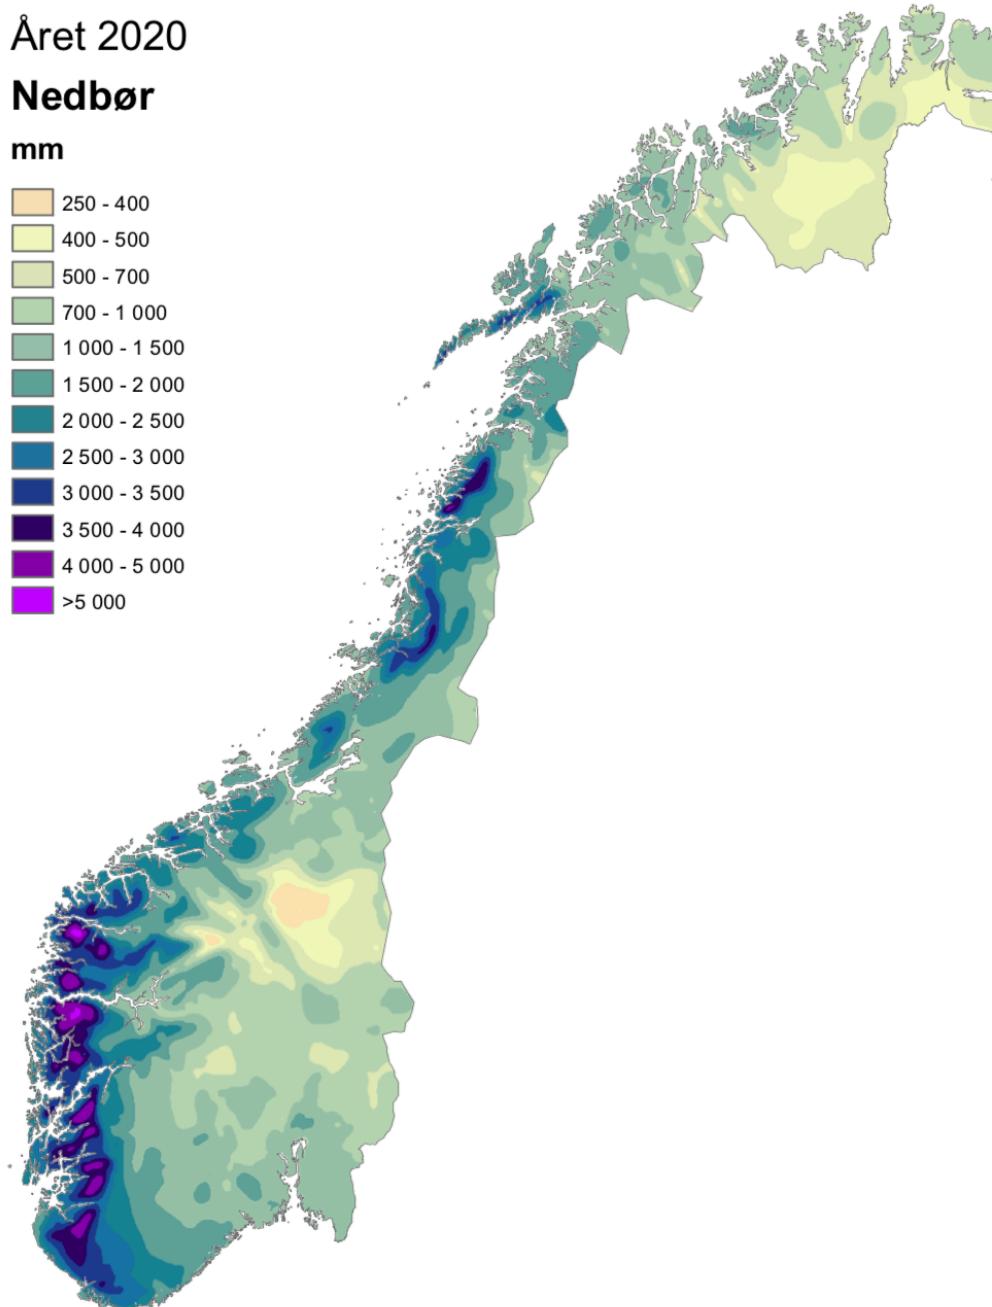
Climatological overview (NORWAY) rain 2020⁷

Normalperioden er 1961 - 1990

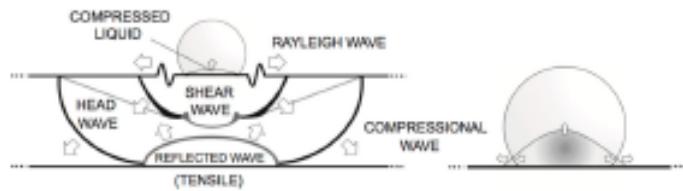
Figure 1 source: *On the Material, Characterisation of wind turbine-B_2017*

Some reports say the coating is polyurethane while "*On the Material, Characterization of wind turbine-B_2017*" says that the cover layer on the Leading edge is also a specially developed epoxy "*developed for Leading Edge Protection*" (LEP)¹⁰. The same report also explains the mechanisms surrounding damage caused by raindrops, defined as the Water Hammer pressure effect.

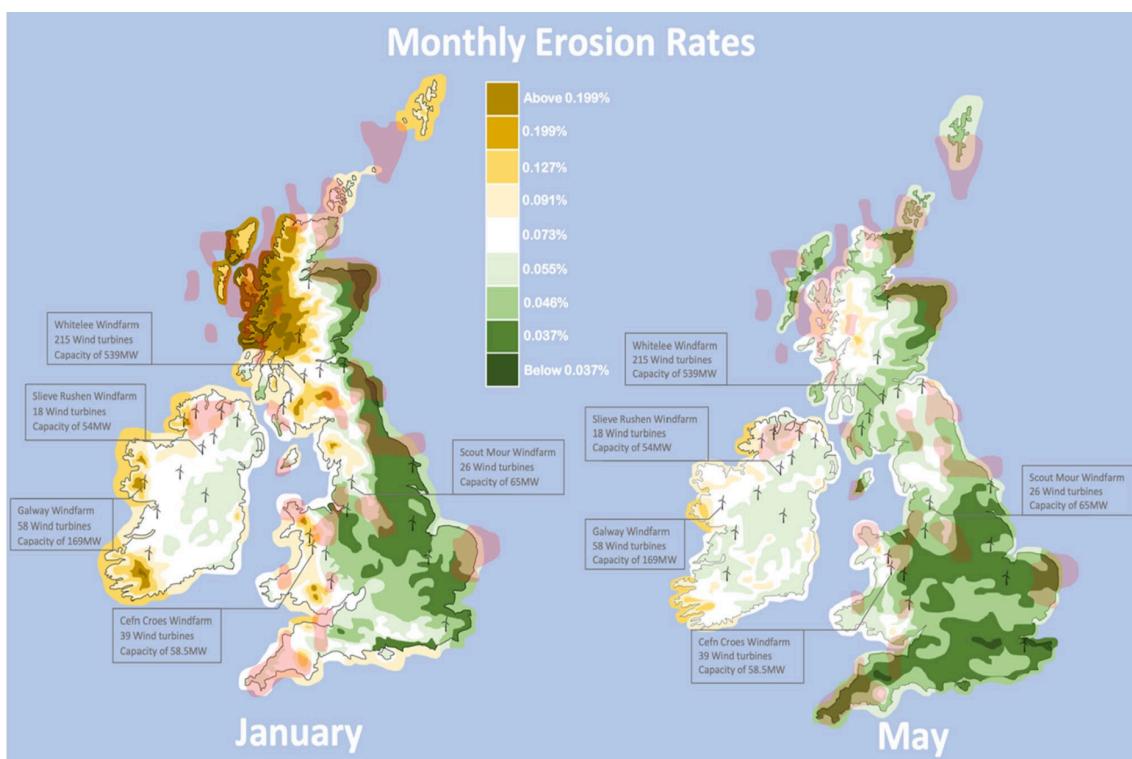
Figure 1. The monthly erosion rates in January and May with overlays of major wind turbine farms and areas of frequent hail. Source: Journal of Bio- and Triboro-Corrosion · March 2021)

The mass of the test material was measured before the experiment and after each exposure time. This will result in a direct numerical relationship between average monthly rainfall and erosion as a mass loss.

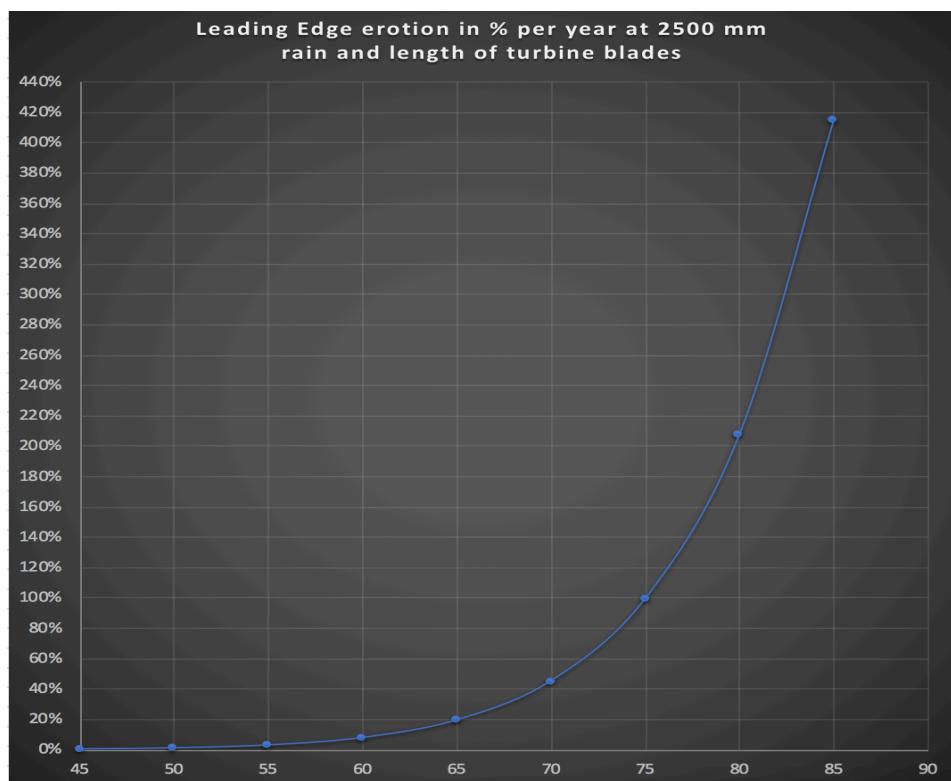
Figure 4. erosion (loss in percent) as a function of precipitation, speed and length of turbine blades

Erosion Rate is exponential to Impact Speed or Impact Energy (see figure 4).

Erosion Rate is exponential to Impact Speed or Impact Energy (see graph)

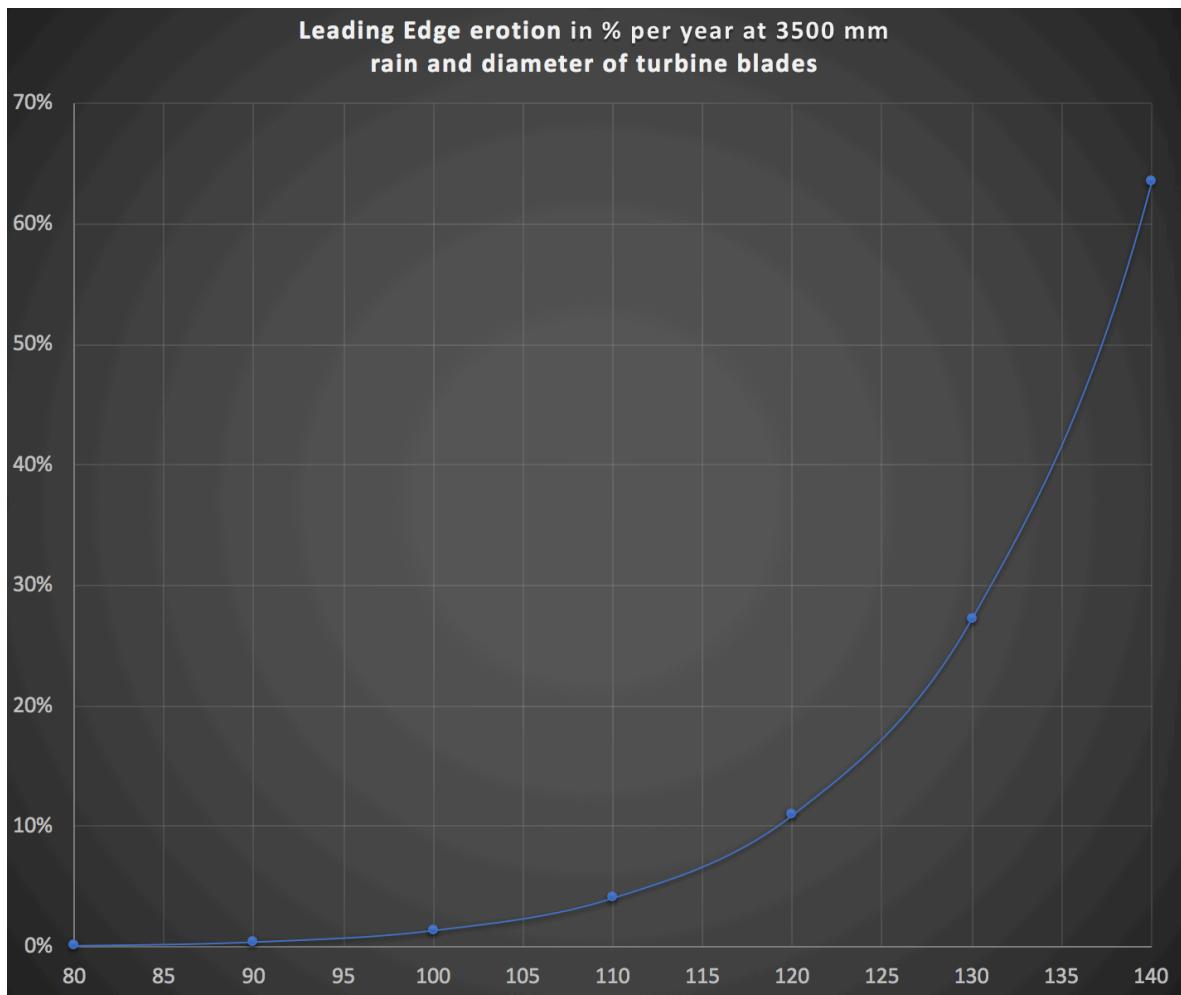
Figure 6. erosion (loss in percent) as a function of precipitation, speed and length of turbine wing

The formula for calculating wear then becomes $f(x) = 1,4 \% * \left(\frac{\text{diameter}}{100}\right)^{11,4}$.

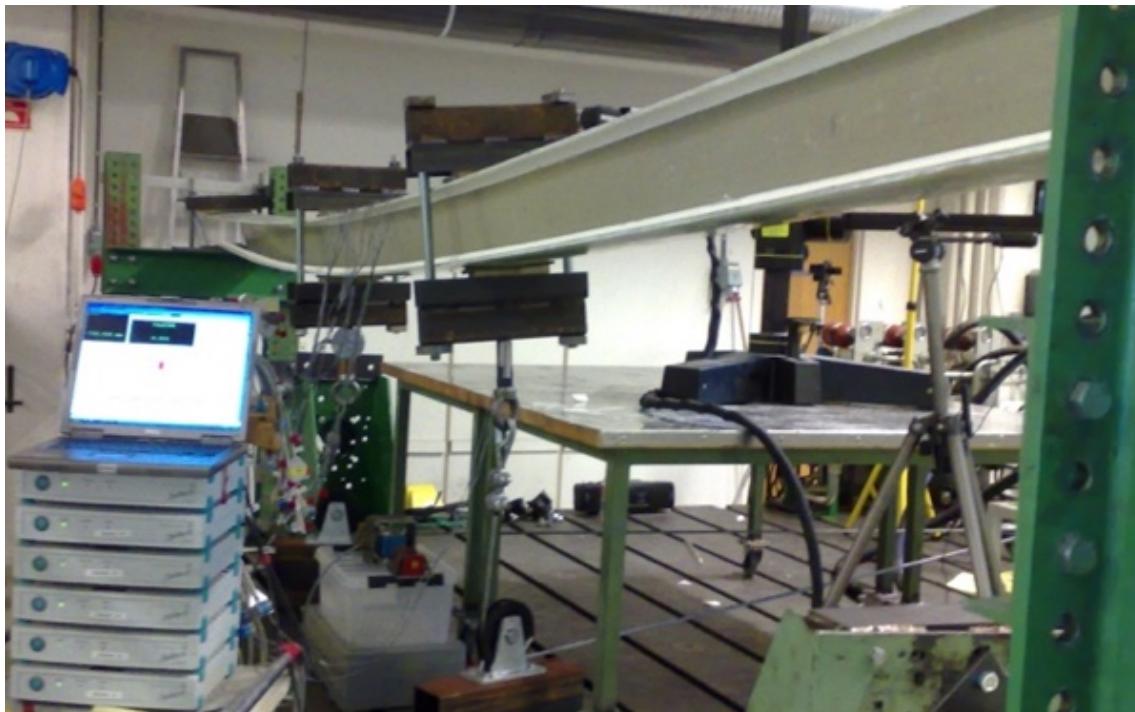
Figure 7 Photo: Bending test of a section on a wing profile. Own photo, from testing
